WEED MANAGEMENT PLAN

SERPENTINE RIVER 2015

Aim: To provide a management plan to eradicate water hyacinth (*Eichhornia crassipes*) from the Serpentine River.

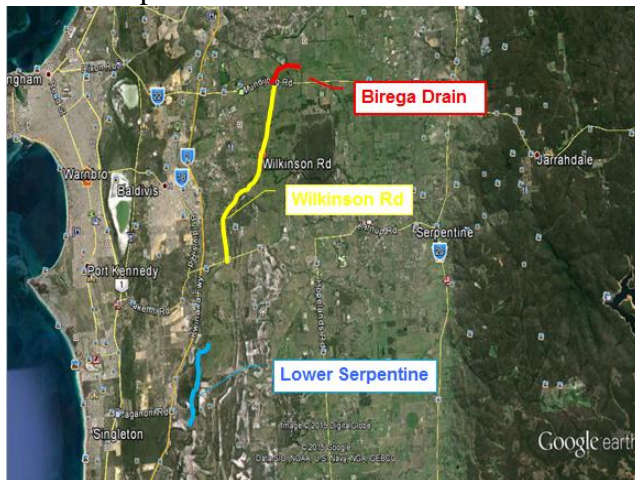
The infestation of water hyacinth (*Eichhornia crassipes*) on the Serpentine River can be considered in three management area, Birege Drain, Wilkinson Road and the Lower Serpentine River.

Figure 1: Infestations of Water hyacinth on the Serpentine River

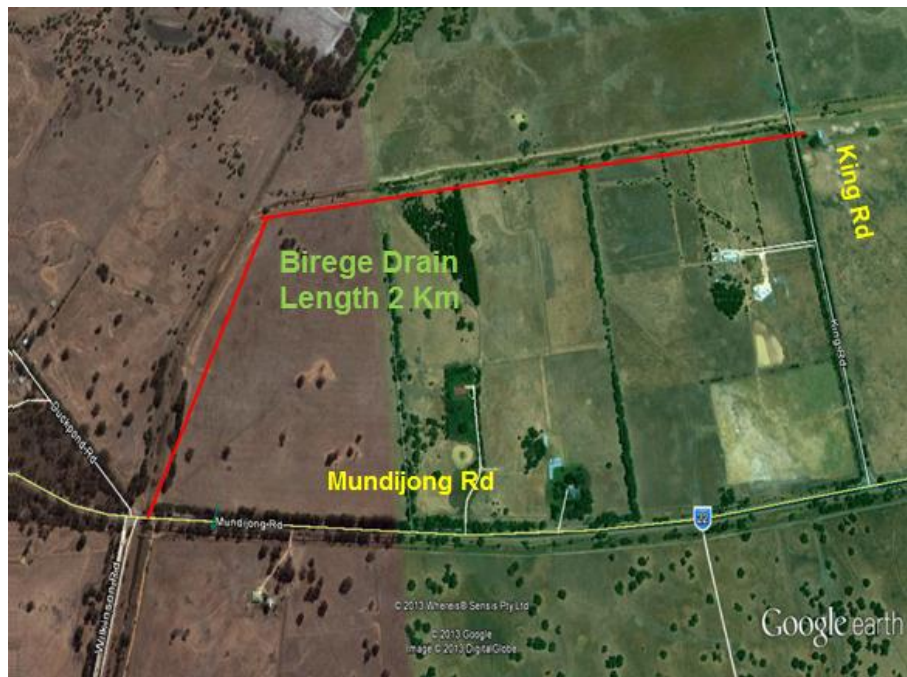
The Birege Drain infestation is a 2km section bounded by Mundijong Road and King Road.

Property ID	3213466
Property Name	
Party Name	WATER CORPORATION - PERTH HQ
Property Area	23.7
Property Type	Drain
Enterprise Type	Not Applicable
LGA	SERPENTINE-JARRAHDALE
